RE: REUSE OF THE PETERS HOUSE – 150 EAST STREET

**EVALUATION FOR REUSE
THE SAMUEL PETERS HOUSE
150 East Street, Hebron, CT**

**PREPARED BY: THE ARCHITECTS
Robert B. Hurd, AIA
56 Arbor Street
Hartford, CT 06106
DATE: December 15, 2005**

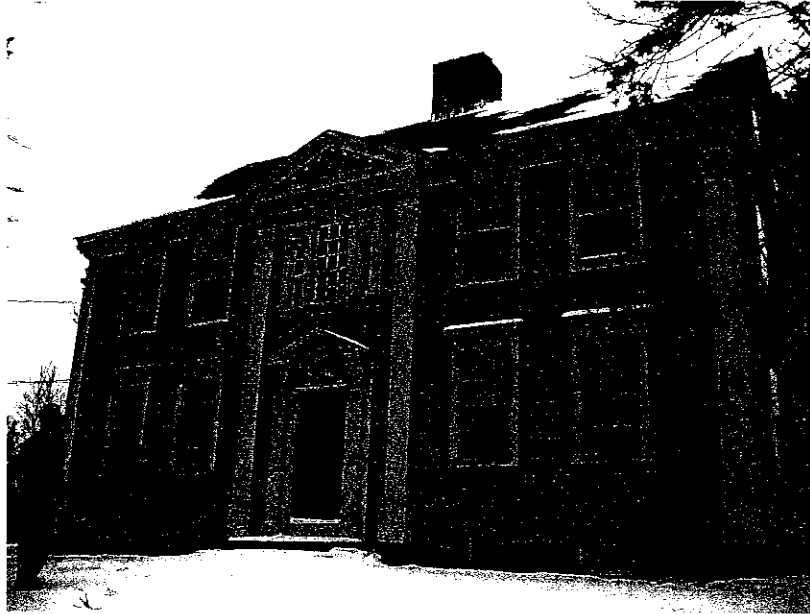
1. Street Façade (cover photo)

The house features a center-chimney floor plan and a highly decorated nine-window facade with a projecting cross gable at the center, paneled Doric pilasters at all corners and the entry door, a fan light over the door and a Palladian window at the second floor. It has a boxed cornice with both crown and dentil moldings. These features suggest a late-Georgian (1760-1780) or early Federal (1780-1800) period of construction (photos 1 and 2).
