RE: REUSE OF THE PETERS HOUSE – 150 EAST STREET

**EVALUATION FOR REUSE
THE SAMUEL PETERS HOUSE
150 East Street, Hebron, CT**

**PREPARED BY: THE ARCHITECTS
Robert B. Hurd, AIA
56 Arbor Street
Hartford, CT 06106
DATE: December 15, 2005**

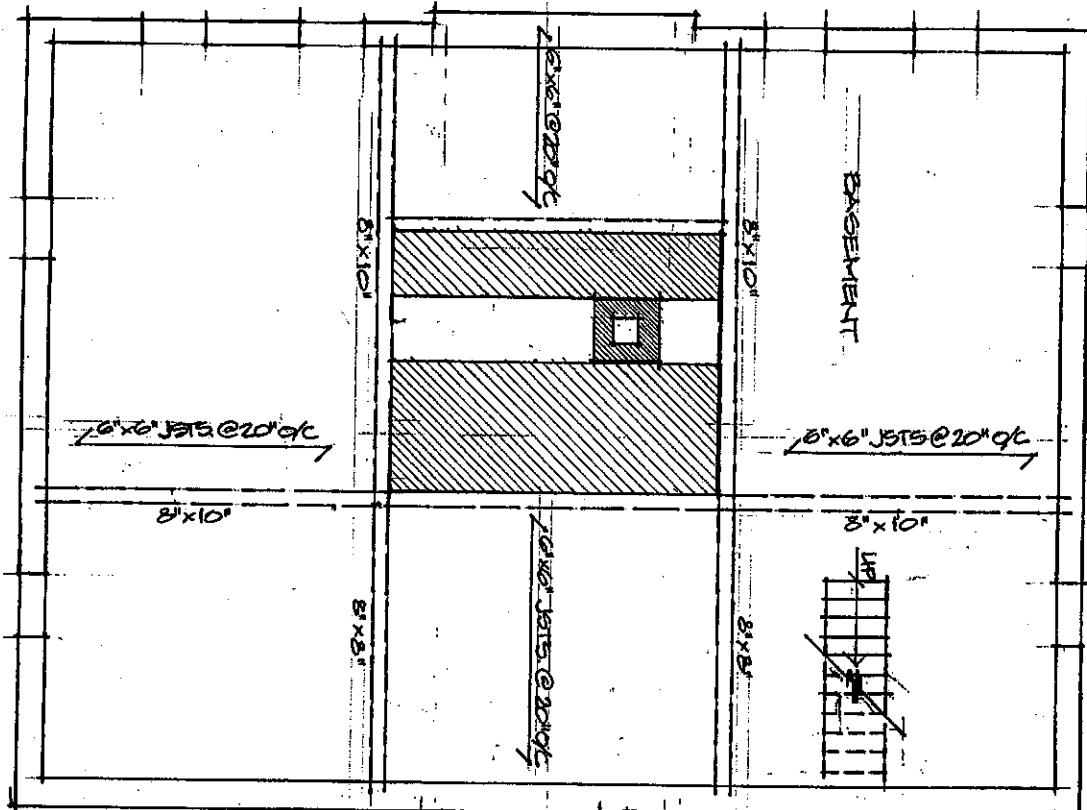
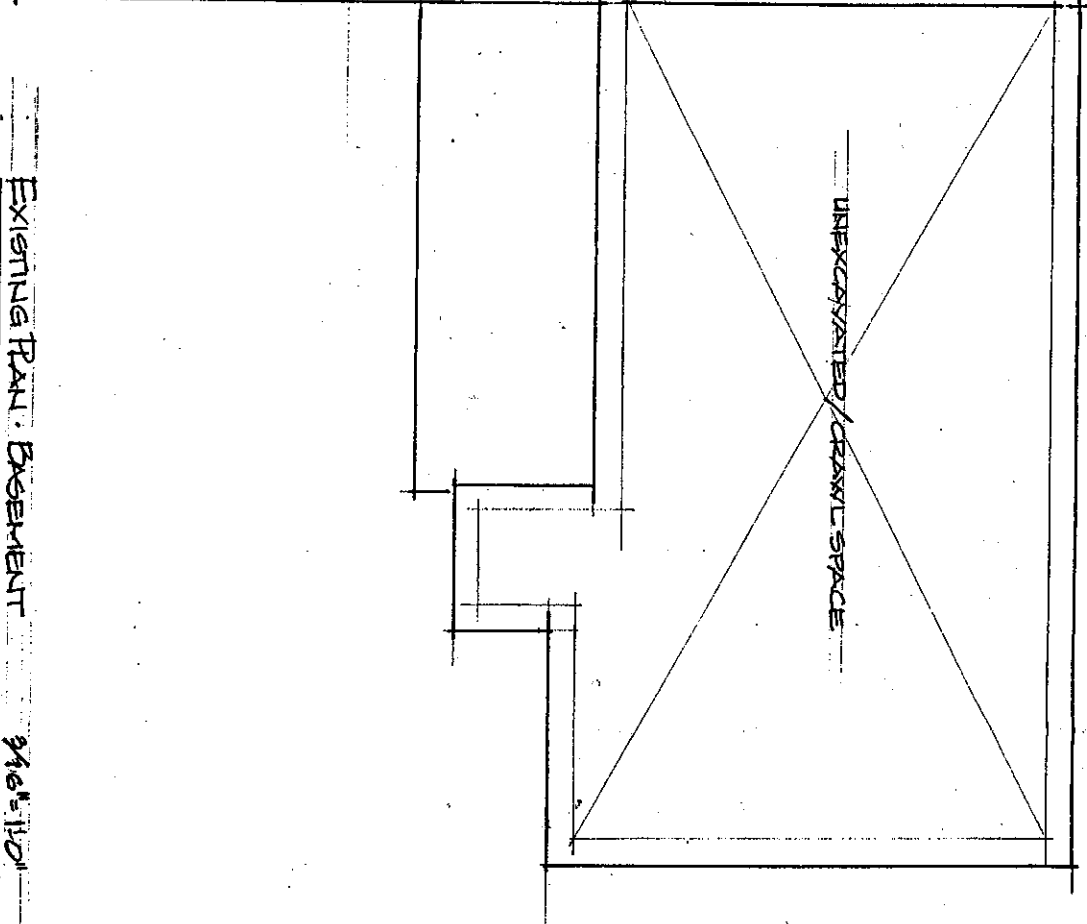
EXISTING PLAN BASEMENT

The foundation is dry set stone with cut brownstone above the grade line at the front and both sides. The clearance between the dirt floor and the summer beams is approximately 7'-0". The walls show signs of repairs over time; the chimney base includes a concrete masonry flue for the single boiler which currently serves the heating needs of the house.
